The recognition of artefacts from acoustic and resistivity borehole imaging devices.

Running title: Recognition of artefact images

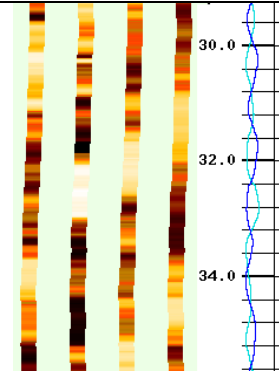
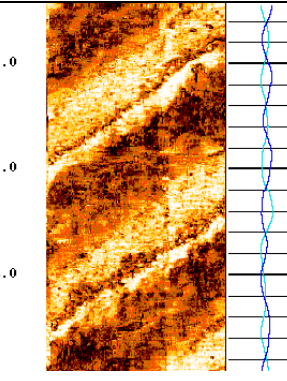
Artefact	Cause - description	Micro-resistivity	Acoustic
<p>1. Acquisition - Drilling</p> <p>Tool Orbiting</p>	<p>Borehole is ‘roller coasting’ (effect caused by certain bit-stabiliser configurations). Affects acoustic tools most severely, often obscuring interpretation. Generally, effect is minimal on resistivity images where it rarely completely impairs interpretation.</p> <p>Left: OBDT false images showing diagonal tool orbiting. Calipers in blue/cyan. (ft).</p> <p>Right: UBI amplitude image showing severe orbiting of borehole, eradicating any useful information. Calipers in blue/cyan. (ft).</p> <p>Box below right: hole orbiting stops with coring @xx42 ft.</p>

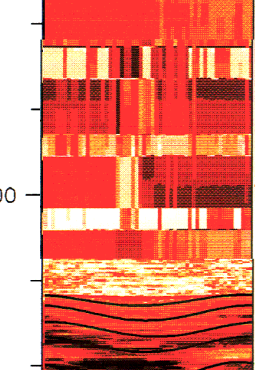
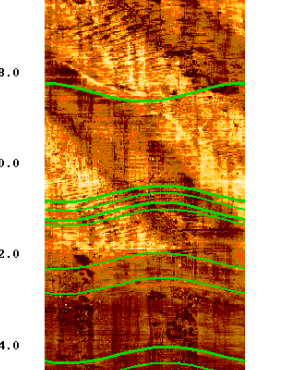
<p>Drill bit slide</p>	<p>Driller allows drill bit to slide, not rotate. Only relevant to LWD (logging while drilling) tools.</p> <p>Left: RAB tool showing a severe slide interval. This results in data under-sampling and a smear of the bottom data in the top half of the image (above xx01). This occurs when the drill bit slides rather than rotates during drilling. Only relevant to LWD tools. (scale ft, horizontal).</p> <p>Right: Described in ‘Tool orbiting’ (above).</p>

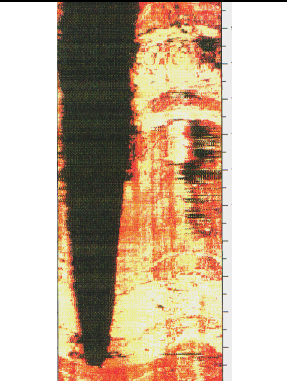
<p>Side-track window</p>	<p>Hole in borehole wall produced when side-tracking. Severe in all imaging tools as this is a physical gap in the borehole wall. Often seen as a conical shape in images up to 20ft in length.</p> <p>Left: See ‘Bit-at-rest’ artefact (below).</p> <p>Right: Horizontal well (20 ft section) showing UBI acoustic image over a side-track window. Note, interpretation is still possible on the right side. (ft).</p>

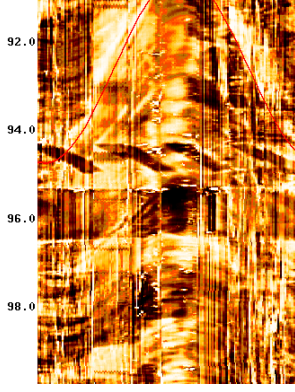
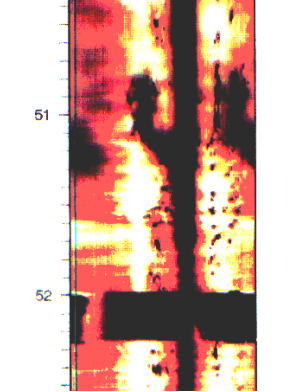
<p>'Bit-at-rest'</p>	<p>Bit/stabiliser imprints produced during drilling. Effect is mild in all images. Consists of a horizontal mark across the image (impression of the bit, left @xx96 ft) and a set of diagonal marks immediately above (impression of the near-bit-stabiliser, (left at xx95 ft).</p> <p>Right: Artefact in an acoustic image. Bit mark at xx52 ft, stabiliser at xx51 ft. (ft, both deviated).</p> <p>Above Left: Bit-stabiliser configuration that can be responsible for 'Bit-at-rest' artefact. Note, the near-bit-stabiliser that produces the diagonal mark.</p>

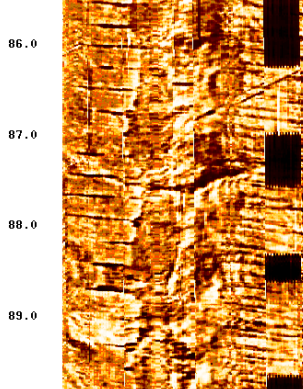
<p>Wiper-trip & Reaming</p>	<p>Processes used to clean the borehole or during coring produce a scratching of the borehole wall. Mild effect in micro-resistivity images and it rarely impairs interpretation. Mild to severe in acoustic tools because these respond much more to the borehole wall.</p> <p>Right: Semi-horizontal to diagonal regular scratch marks caused by the reaming of the borehole wall on a microresistivity device. (one pad is also malfunctioning as shown by the black areas to the right of the image. (ft, deviated, bit size - 6 in).</p>	<p>Mild effect on micro-resistivity images.</p>

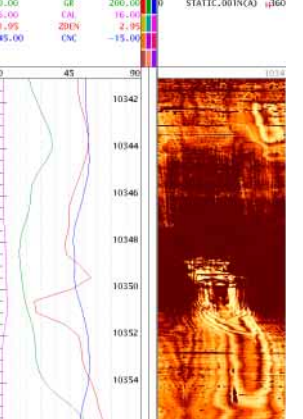
<p>Debris material in borehole</p>	<p>Material from drilling that is lodged in borehole wall.</p> <p>Right: Acoustic image showing a disused drill-bit that is lodged in the borehole wall shown by density spike (red curve) and a high amplitude acoustic (light area) image half way down the diagram surrounded by a low amplitude area (dark image)</p>

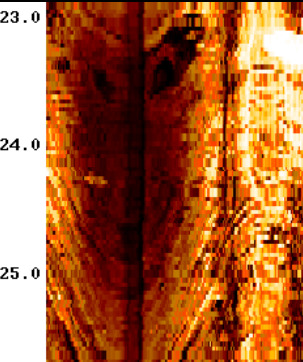
<p>Acquisition - Logging</p> <p>Eccentralisation/stand-off</p>	<p>Logging tool is not centred in the borehole. This causes one side of the image to be too near the borehole wall, and one side too far away. Effect is mild on micro-resistivity images because these are pad devices that touch the borehole wall, unless the hole diameter exceeds the operational diameter of the tool. On acoustic images however, it is often severe (especially the transit-time image) as these are centred devices (held centrally by stabilisers/stand-offs). Common with pipe-conveyed logging.</p> <p>Right: Acoustic amplitude image showing a broad vertical darkening down the left side of the image and a light strip down the far-right side. (NB there is also a very dark vertical strip, this is a stabiliser mark). This is caused by the eccentralisation in this horizontal borehole. Tool is falling to the low-side of the hole which is the lighter side of this image, to the far-right and is confirmed by a broad 'key-seat' to the right. (ft, bit size – 8in, referenced to north).</p>

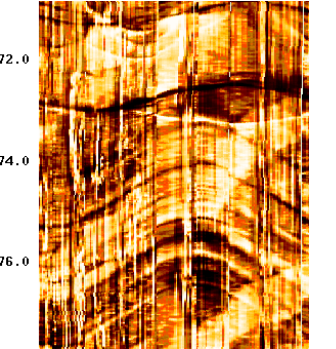
<p>Mud smear</p>	<p>Mud build-up on electrode buttons, missing button data causes a vertical striping. Effect is mild to severe on micro-resistivity images depending on mud used, tool speed and tool type.</p> <p>Left: Mud smear on separate buttons of a FMI micro-resistivity device causing vertical striping. Buttons become smeared then clean by themselves due to pad friction with the borehole wall. The effect does not severely inhibit interpretation in this example. (m, deviated, bit size 6 in).</p>

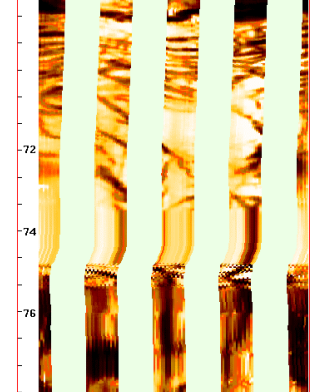
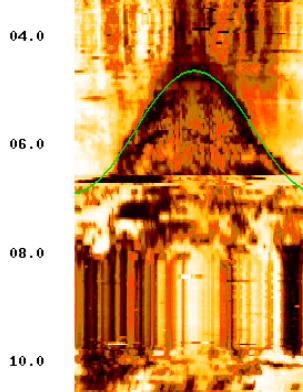
<p>Not applicable to acoustic tools as they do not have electrodes.</p>
<p>Tool Speed Irregularities</p> <p>1) Stuck Zones</p>	<p>Erratic breaks in an image resulting in a compression/expansion of the image over a small interval. Caused by sudden differences in tool speed and the yo-yo effect of wireline cable. Interpretation is often impaired. Refer also to Bourke (1989), Fig. 3a.</p> <p>Left: 4 pad micro-resistivity device with a tool stick and resulting data expansion over the base of the image (below xx75 ft) and compression just above at xx74 ft.</p> <p>Right: Acoustic image with expansion at the base (xx8-10 ft) and compression at xx7 ft.</p>

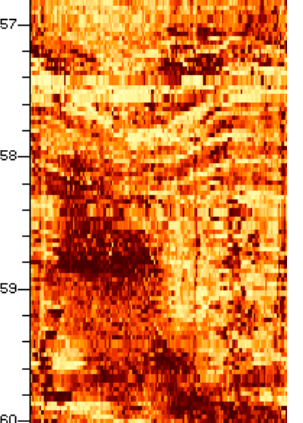
<p>Tool Speed Irregularities</p> <p>2) Sticky zones</p>	<p>Logging tool has suffered minor sticking possibly visualised as a minor tool juddering. Often the appearance of 'saw tooth' on micro-resistivity images. Interpretation is not often impaired.</p> <p>Left: single pad of a micro-resistivity device with a saw-tooth appearance, common within sticky zones. (vertical extent 200 mm).</p> <p>Right: Acoustic image over a 'sticky' interval where the tool motion is erratic or 'jerky' but has not caused a severe stick. The results are blocky patches across the image at xx57.4 ft, xx58.3 ft and xx59.4-59.9ft.</p>

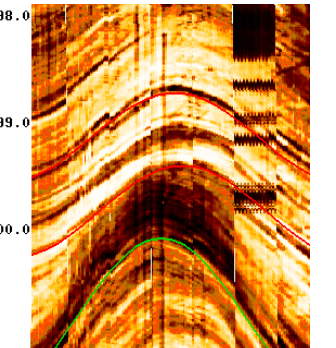
<p>Button or flap 'death'</p>	<p>Electrical fault on micro-resistivity devices usually a single button or complete pad, resulting in missing button data and interrupted image. Mild-severe to severe affect on interpretation.</p> <p>Right: One single pad of an 8 pad-flap FMI micro-resistivity device is malfunctioning as shown by the interrupted image on the right of the image above xx00.0 ft. Interpretation is not inhibited in this example. (ft, vertical, bit size 6 in.).</p>

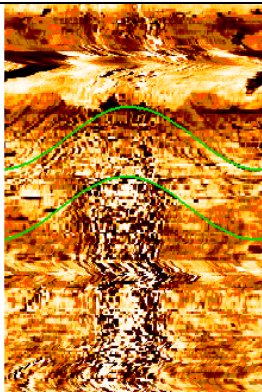
<p>Faulty inclinometry data</p>	<p>Either one or all of the 3 accelerometer or magnetometers are faulty which give an incorrect orientation of the images. Resulting dip magnitude and azimuth will therefore be in error. Effect is severe on subsequent interpretations and thorough checks of inclinometry data should always be made before interpretation.</p> <p>The artefact is common at the top of logging runs where the inclinometer enters the pipe ahead of the image tool (which causes the magnetometers to malfunction due to the magnetic effect of the casing). The result is incorrectly displayed image data over an interval generally related to the length of the tool.</p> <p>Right: Acoustic amplitude image showing zigzag patterns especially at xx5.0 m and just below xx6.0m although other minor rotation disruptions are present in between. These are caused by magnetometers that are malfunctioning. The subsequent dips azimuth and magnitude are likely to be affected.</p>

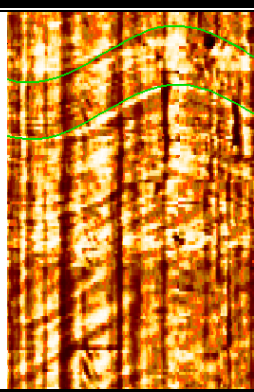
<p>Excessive tool rotation</p>	<p>Logging tool rotates at a speed greater than the acquisition system can sample data. Results in an under-sampling of the inclinometry data. Generally a problem when the tool rotates >1 rotation per 30 ft (10 m). The result is commonly reduction of the precision and accuracy of the dip magnitude. This artefact is common with a mild to severe effect on interpretation in both micro-resistivity and acoustic images.</p>	<p>Notable by a fast rotation of the orientation Pad 1 Azimuth and Relative bearing curves. Not often noticeable on images at high display scales (<1:20)</p>
<p>Noise: '60 Hertz'</p>	<p>Acquisition current noise - operating frequency interference, resulting in diagonal stripes across images. Can be common/ with a mild-severe effect in all tools.</p> <p>Right: acoustic image (UBI) with clear right-to-left diagonal stripes. Generally visible at low EMEX voltage. Can be successfully filtered. Interpretation is still possible although there is also a vertical stripping attributed to stabiliser grooves scarring the borehole.</p>

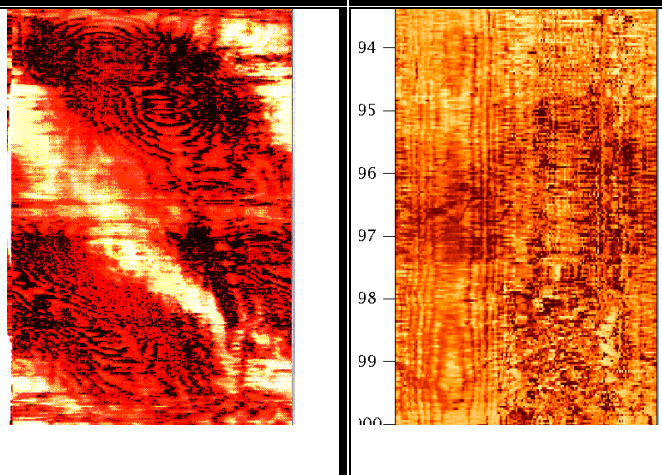
<p>Processing Noise: 'Woodgrain'</p>	<p>Processing noise resembling woodgrain texture. Only applicable to acoustic images. This artefact can be common with severe results often inhibiting interpretation (right). Caused by systematic errors in acquisition peak interpolation. This can be ameliorated by filtering. A similar artefact is caused by an interference multiple effect (similar to a fresnel effect), see derived image artefacts.</p> <p>Left: 'Woodgrain' effect occurring within a hole spiral from a STAR2 tool. Common in heavy muds. (4 ft, vertical). Right: woodgrain texture clear to the left of the UBI image, caused by peak interpolation errors. (ft, deviated, 12.25 in. bit size).</p>

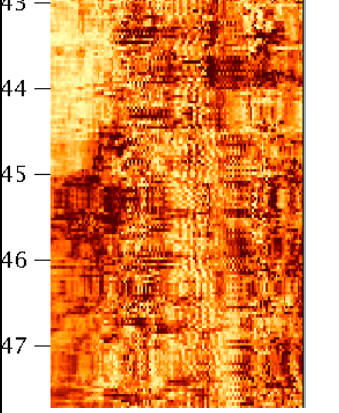
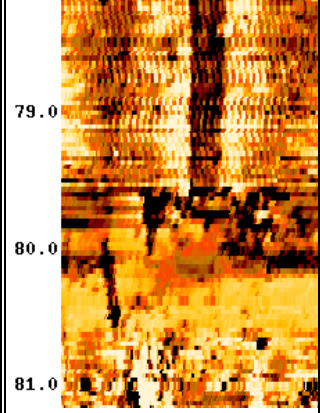
<p>Processing Noise 'Honey-comb'</p>	<p>Regular horizontal comb pattern on the amplitude of acoustic images. Caused by errors in calculation of the amplitude gain during acquisition. The tool changes its gain on each sample, each gain is corrected based on statistics from the previous sample – if correction is miscalculated it results in honeycomb pattern. Can be common with mild-severe effect. N/A in micro-resistivity devices</p> <p>Left: amplitude image with honeycomb texture noticeable to right of image. Interpretation is impaired (ft).</p> <p>Right: honeycomb texture stops below xx79.5 ft.</p>

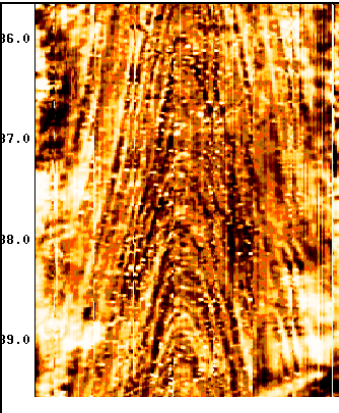
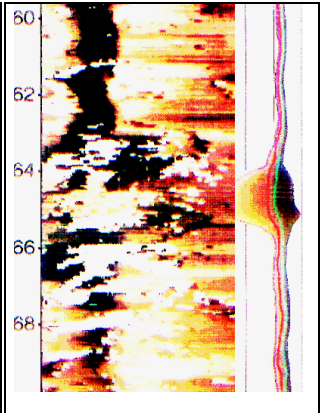
<p>Signal Loss</p>	<p>Degradation in signal/noise ratio. Seen in all devices for various reasons. Rare but can be mild to severe in effect.</p> <p>Left: 8 pad-flap micro-resistivity device showing a spotted texture attributable to oil based mud lubricant additives (up to 8%) in water based mud. The effect does not inhibit interpretation in this example. (ft).</p> <p>Right: More common in acoustic tools are the white patches on travel time image representing areas where returned travel time (TT) falls outside of the measurement window. See dispersion (right side) of TT at xx65 ft. Common in washouts. (ft).</p>

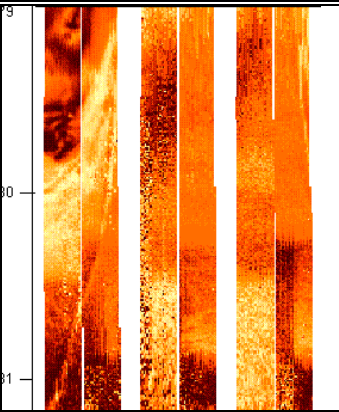
<p>Extremes of condition</p>	<p>Dynamic range of tool exceeded. Common in high resistive lithologies as a crystalline like speckling on an resistivity image.</p> <p>Left: 'Crystalline speckling' in a very highly resistive lithology (evaporite) where the micro-resistivity tool has reached its maximum dynamic range. Lithology at top left is a shale. (ft).</p>

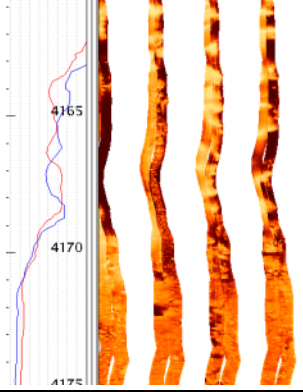
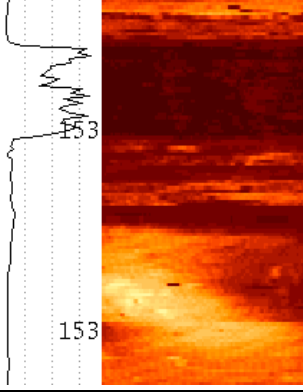
Artefacts	Cause - description	Micro-resistivity	Acoustic
<p>2. Borehole Wall artefacts</p> <p>Washout</p>	<p>Enlargement of the borehole hole diameter and corresponding de-focusing of image and giving a patchy image. Severe effect on all image logs.</p> <p>Left: Micro-resistivity image and calipers (left in blue/red increasing to right) showing de-focusing of the image as a washout is encountered above 4170 m. Interpretation is inhibited above.</p> <p>Right: dark area on an acoustic log and associated caliper deflection (left) indicate a large washout at xx153 ft.</p>

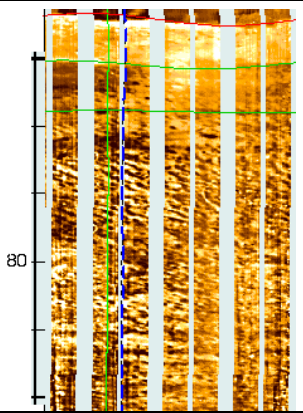
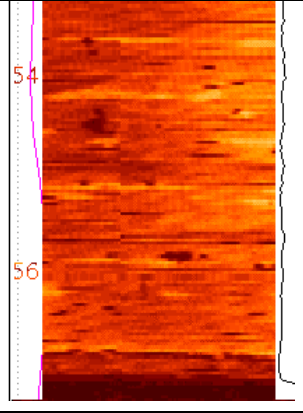
<p>Rugose hole</p>	<p>Pitted borehole wall. Common on acoustic logs with a mild to severe effect on interpretation. Rarely noticeable on micro-resistivity images.</p> <p>Left: Extremely massive, homogeneous sand with Darcy permeability showing a hatchy texture, probably rugosity. (ft).</p> <p>Right: Acoustic image showing dark and light patches with a corresponding erratic caliper (black curve right side is the caliper, increasing to the right). This corresponds to rugosity of the borehole wall. (ft, 8. In. bit size).</p>

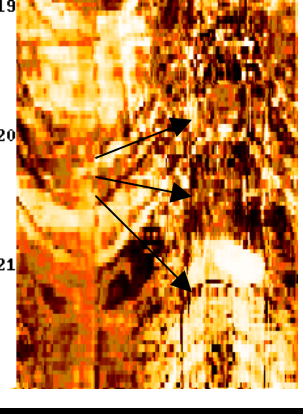
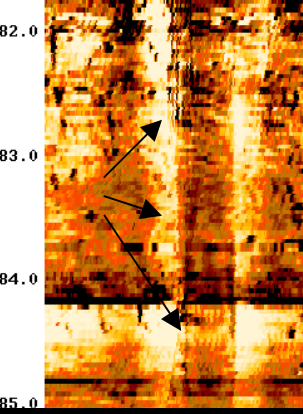
<p>Key-seat Furrow</p>	<p>Ovalisation due to bit wear on underside of the wellbore. Noticeable in deviated wells with often only mild effects as a broad vertical stripe.</p> <p>Left: micro-resistivity FMI image showing a broad vertical key-seat furrow towards the right hand side. (ft, 6.25 in. bit size),</p> <p>Right: Vertical key-seat furrow in an acoustic CBIL image. More visible just right of centre (see arrows). (ft, 8.5 in. bit size).</p>

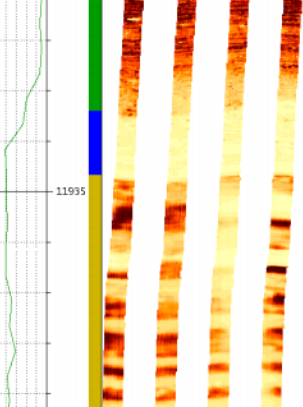
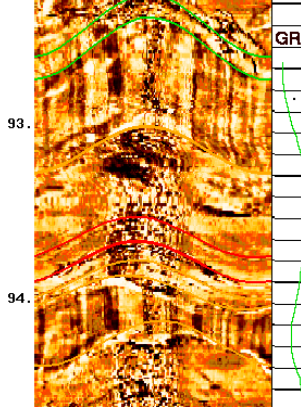
<p>Mudcake Build-up</p>	<p>Build up of mudcake generally over permeable lithologies. Effect can be mild to severe, often inhibiting interpretation.</p> <p>Left: Micro-resistivity FMS image showing a transition from a shale above 11935 ft to a permeable sand below. A mud cake has formed over the sand giving a blur to the image and masking bedding. Gamma-ray to left (increasing to the right).</p> <p>Right: Acoustic UBI image showing mudcake buildup and latter stabiliser scratching over sand layers in a sand-shale sequence. These are indicative of mudcake build-up in sands. Gamma-ray to right. (ft)</p>

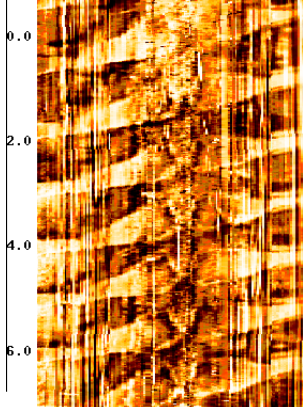
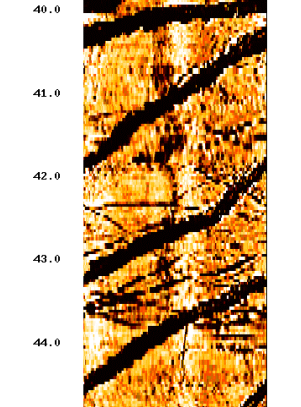
<p>Spiral Hole</p>	<p>Borehole wall is grooved due to scratching by the bit. Often leaves a diagonal mark similar to hole orbiting. Common effect in all logs, although more severe on acoustic images.</p> <p>Left: Horizontal FMI showing regular diagonal marks representing catching of the bit which is scratching the borehole wall. Button smear is also seen as vertical marks on this image. (ft, 6 in. bit size).</p> <p>Right: Black diagonal marks on a acoustic tool are scratch marks that are filled with drilling mud appear as low acoustic impedance. (ft, 6in. bit size). From Lofts <i>et al.</i> (1997).</p>

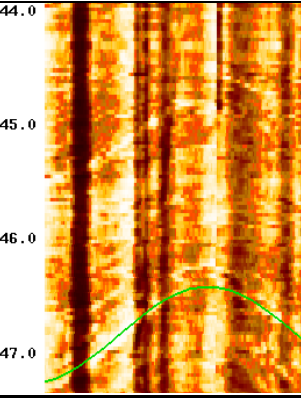
<p>Tool Marks: A/ Stabiliser grooving</p>	<p>Vertical striping on the borehole wall caused by scratching of the logging tool stabilisers. Acoustic tools are highly sensitive to the borehole wall condition as is seen here.</p> <p>Right: Light and dark vertical stripes in an acoustic CBIL image. Often only partially obscure interpretation. Bedding can in fact be identified below xx46 ft shown as a green sinusoid.</p>	<p>Rarely noticeable in micro-resistivity images.</p>

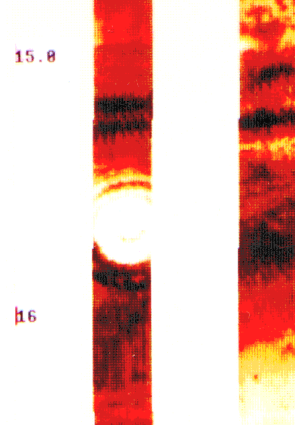
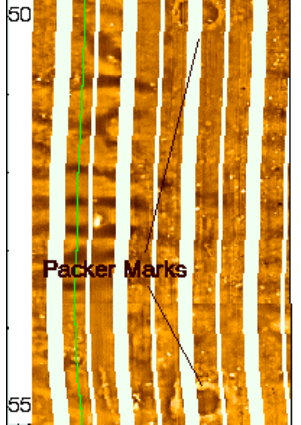
<p>B/ Sampling tool probe & packer marks</p>	<p>Marks made by probe/packer sampling tools. Seen in all tools as distinctive rounded marks left in mudcake or soft lithologies like the massive sand on the right. Commonly mistaken for cementation nodules. Effects are rarely serious on interpretation.</p> <p>Left: Resistivity image of two pads of an FMS tool showing an RFT probe/packer on mudcake. (ft, unknown bit size).</p> <p>Right: Two probe/packer marks on a micro-resistivity FMI image in a soft massive sand lithology. (ft, 8.5 in. bit size).</p>

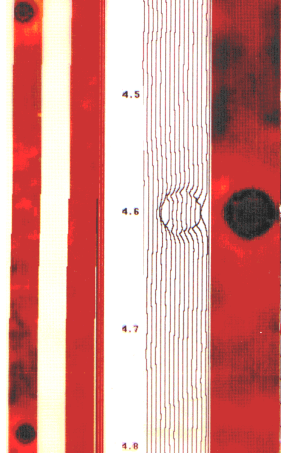
<p>C/ Sidewall core sample points</p>	<p>Marks made by a mechanical sidewall corer device. Usually seen as dark spots where mud fluid replaces the sample that has been extracted.</p> <p>Left: Spilt image showing two sidewall core samples (left) and a zoom showing a single core sample and resistivity profile over that core sample (right). These are easily identified as they are symmetrically round shapes. (ft) unknown bit size.</p>

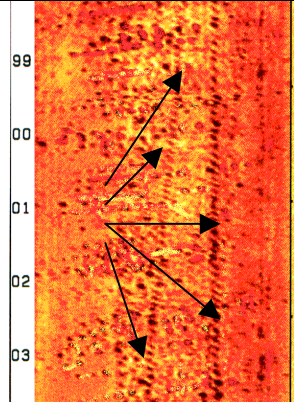
<p>Possible in acoustic images, similar in appearance to micro-resistivity images</p>
<p>Cable 'slap'</p>	<p>Marking of wireline cable on borehole wall. A very subtle artefact and relatively uncommon. Most noticeable in acoustic images.</p> <p>Right: acoustic CBIL image showing two marks made by the cable 'slapping' the borehole wall, one almost vertical and one slightly diagonal in the centre of the image (see arrows). (ft, 8.5 in. bit size).</p>	<p>Not common in micro-resistivity images.</p>

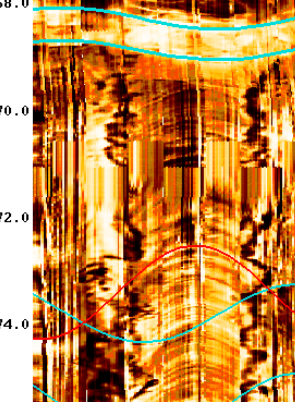
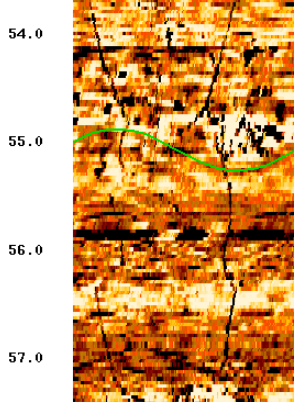
<p>Drilling induced fractures</p>	<p>In general, zigzag fractures parallel to well bore axis. Caused by drilling process and indicates the predominant in-situ stress direction (sigma 1). Easily identified and useful in situ-stress determination.</p> <p>Left: Micro-resistivity FMI image showing two parallel zigzagging vertical fractures in a deviated well bore. Image also suffers from some mud smear on various buttons especially to the left. (ft 6.25 in. bit size).</p> <p>Right: Hairline zigzag fractures very clearly visible in an acoustic image parallel to the borehole axis. (ft, 8.5 in. bit size).</p>

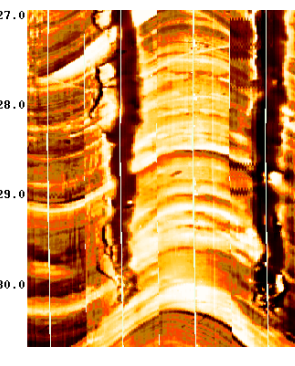
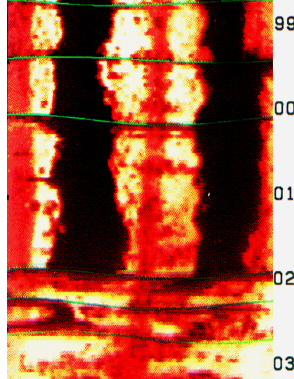
<p>Drilling induced breakout</p>	<p>Broad parallel grooves separated by 180 deg and parallel to borehole axis. Caused by shear failure fractures orthogonal to the main in-situ stress direction and therefore useful in situ-stress determination. Generally, they do not fully inhibit interpretation.</p> <p>Left: Micro-resistivity image showing the broad breakout features which are dark as they are filled with conductive drilling mud. (ft, 6.25 in. bit size).</p> <p>Right: Acoustic image showing breakouts as wide dark area which abruptly terminate at xx02 ft as the lithology changes.</p>

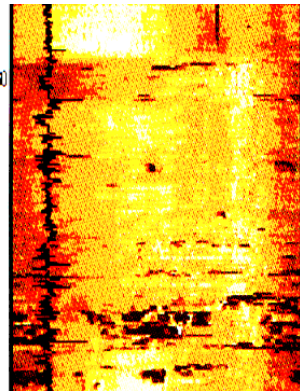
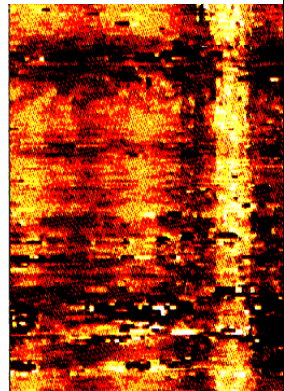
Incorrect colour assignment	Results from the skew of the image histogram by an anomalous high or low resistivity/amplitude image. Saturated looking images – concealment of detail.	Not common in modern images	Not common in modern images
Incorrect gain correction	<p>Wrong gain correction is applied during processing of images. Resulting in under saturated/over saturated images. Can appear in all logs.</p> <p>Left/right: Static acoustic images showing a raw uncorrected image that is saturated (left image) and one that has had a proper gain correction applied (right image). More detail is visible and the image is not so washed out. (ft, 8.5 in. bit size).</p>

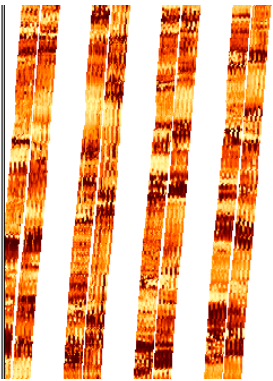
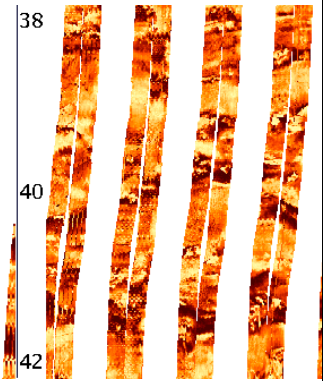
Faulty button correction	<p>‘Tiger striped’ images that appear fuzzy. This results from the incorrect processing and correction for the faulty electrodes. Generally only occurs if there is a faulty acquisition circuitry.</p> <p>Left: FMI tool with an inferior correction applied.</p> <p>Right: Same image with correct processing applied.</p>

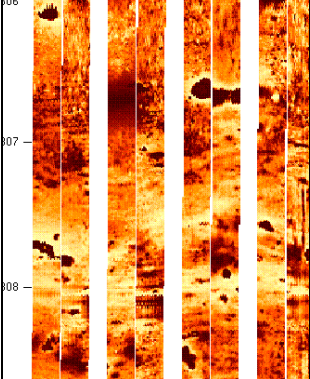
Artefact	Cause - description	Micro-resistivity	Acoustic
<p>4/ Derived Artefacts.</p> <p>Current Gather</p> <p>Effects:</p> <p>Halo effects - Conductive</p>	<p>Light rim or 'halo' surrounding a conductive feature. This results from the flow of current toward the most conductive pathway. This 'current gather' leaves a resistive rim where current is lacking around such a feature.</p> <p>Left: Current gather seen around pyrite nodules, which are extremely good conductors of electrical current. The best example is a dark nodule at xx06.5 ft. (ft, bit size 8.5 in.).</p>

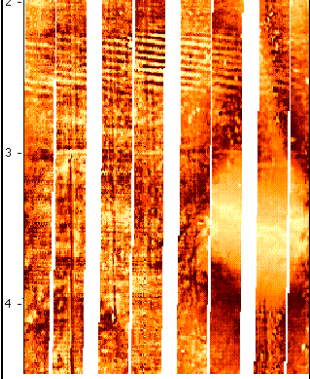
<p>Not applicable to acoustic tools.</p>
<p>Halo effects - Resistive</p>	<p>Dark rim or 'halo' surrounding a resistive feature (light). This results from the drain of current away from the most resistive areas to the more conductive pathway. This 'current gather' leaves a conductive rim where current is gathering around such a feature.</p> <p>Left: Large resistive cemented nodule (light colour) surrounded immediately by a dark halo indicating current gather.</p>

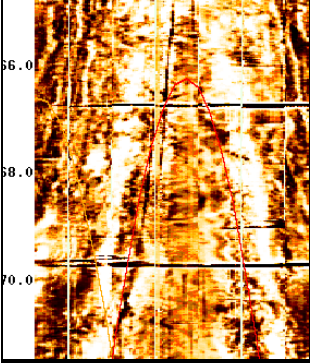
<p>Cement mottling</p>	<p>Mottling fabric caused by highly resistive cements. Again this is an effect caused by current gather. In the case of cements, they are generally resistive and result in a mottle fabric as current drains to a more conductive area.</p> <p>Left: White 'mottled' area following the outside of the red sinusoid is to current gather over a resistive bedding horizon. (Horizontal well with shallow bedding makes bedding surfaces here very steep sinusoids). (ft, bit size 8.5 in.).</p>

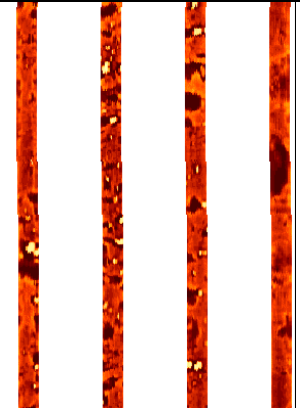
<p>Proximity features</p>	<p>Patchy texture caused by current gather/around resistive and conductive features (such as nodules) proximal to the borehole wall but not actually touching. Refer to Williams (1996).</p> <p>Left: Benthic shells in a mudstone showing dark blotchy texture which is attributed to proximal features not actually touching the borehole wall and not seen in core at this depth.</p>

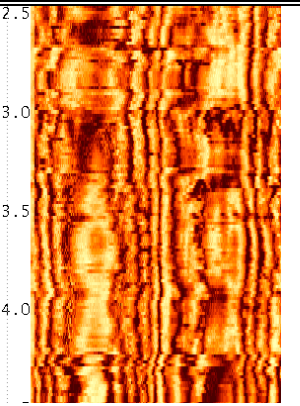
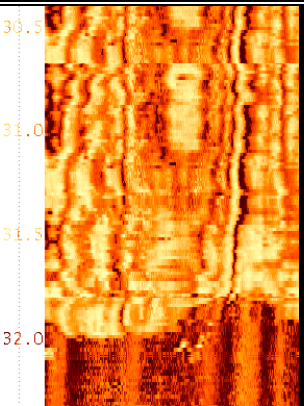
<p>Not applicable to acoustic tools.</p>
<p>Woodgrain 2</p>	<p>Processing noise resembling woodgrain texture. Explained as a multiple or interference effect which occurs in heavy muds and within heavy mudcake intervals. With reflections from tool housing. Only applicable to acoustic images. This artefact can be common with severe results often inhibiting interpretation (right).</p> <p>Left: Woodgrain effect in a heavy mudcake on a CBIL image. (ft, 8.5 in. bit size)</p> <p>Right: Woodgrain effect commences where heavy mudcake starts in a permeable zone above xx32 ft. (ft, 8.5 in. bit size)</p>

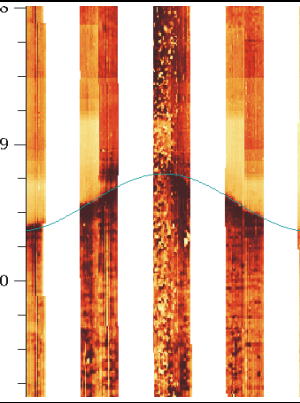
<p>Residual (remaining) Hydrocarbon</p>	<p>Imaged oil-water contact (at xx9.75 ft) in a sandstone lithology. Within the oil zone the resistivity image is highly resistive (bright yellow) and within the water zone the sandstone has a normal resistivity profile. Core is displayed on right side showing no change in lithology and confirming oil stain. (ft)</p>
